Survey for Njord A at Halsnøyfjorden

Survey Report | 13 to 15 February 2021 | Halsnøyfjorden

161637-07-REP-001 Issue 1 | 26 February 2021

Equinor ASA

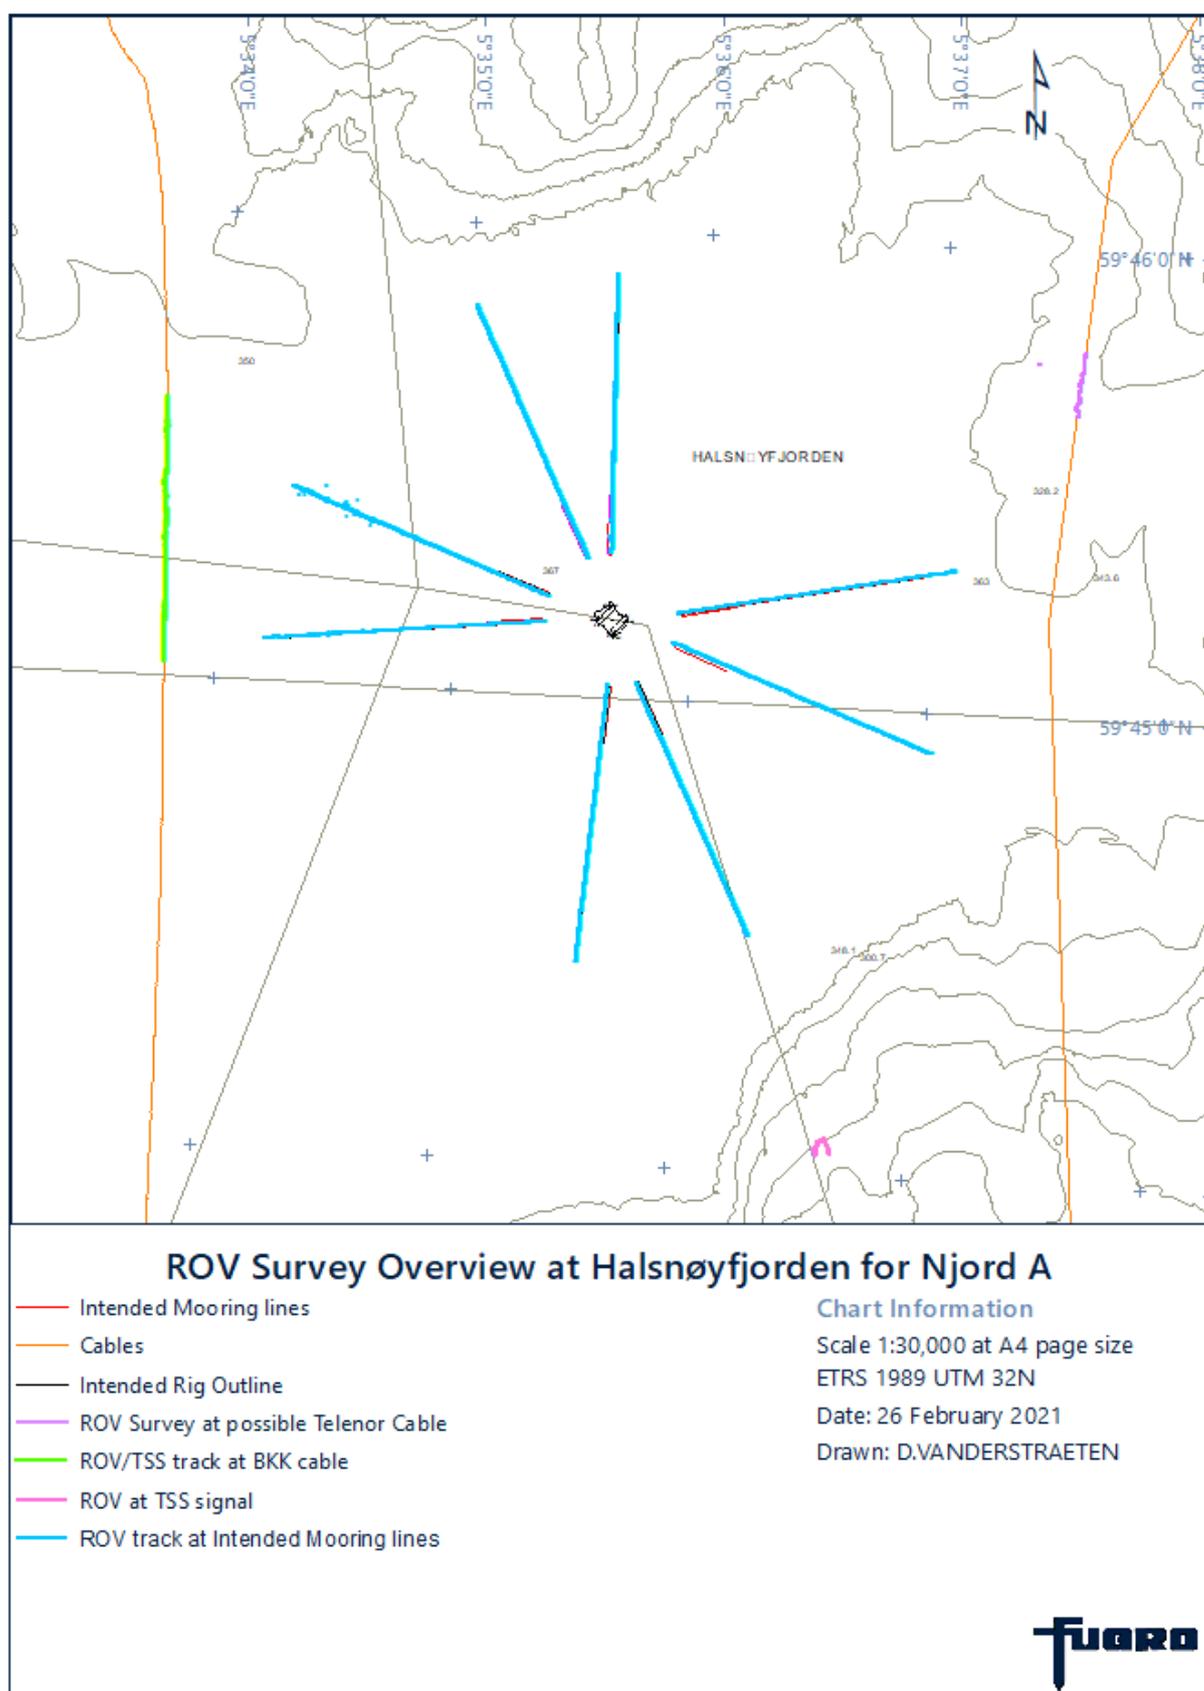
Figure 5.1: Survey Plot Overview at Halsnøyfjorden

All eight mooring line corridors were visually surveyed without any boulders, pockmarks, scars, or corals found. The inspection of the seabed indicated soil characteristics consisting of soft clay.

A TSS pipe tracker was installed on the ROV, and a survey along the route of the Telenor telecommunication cable indicated on electronic chart was attempted. Only weak and sporadic signals were detected, and it was not possible to confirm if the signals indicated the cable or noise or from other objects underneath the seabed.

The survey of the BKK fibre optical cable on the west side of the planned mooring-spread location aligned well with the electronic background chart. The signal from the pipe-tracker was clear throughout the surveyed route, and the cable was also exposed for a few metres along the route.

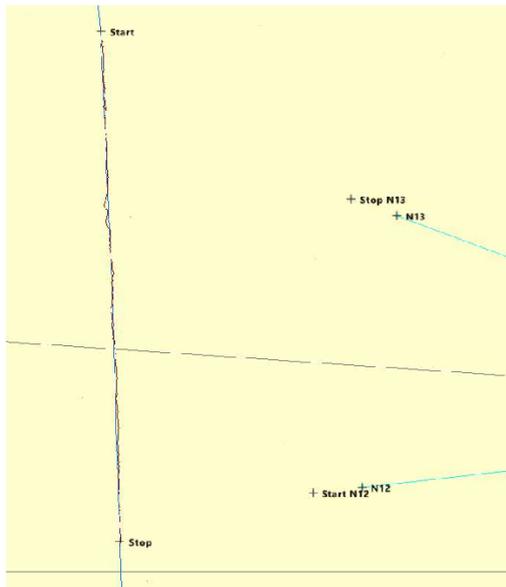
Figure.2: Print screen from navigation software

Figure. shows a print screen from the navigation software showing ROV/TSS track.
